# BELZONA REPAIRS BROKEN DIELECTRICS

ID: 542

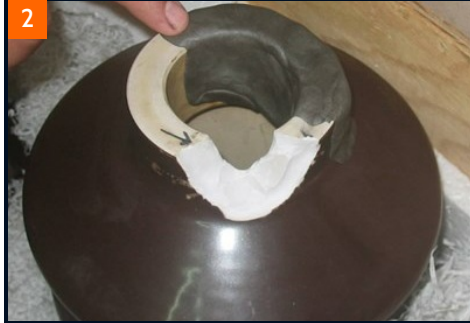
Dielectrics were broken at their edges causing oil infiltration from the connecting transformer.

1. The broken dielectrics
2. Making a former on the good edge using Belzona 1111
3. Reforming the broken edge
4. The two repaired dielectrics
