# BELZONA REPAIRS AND PROTECTS GASO TREATER

ID: 5420

Heavy Gas treatment vessels in a refinery

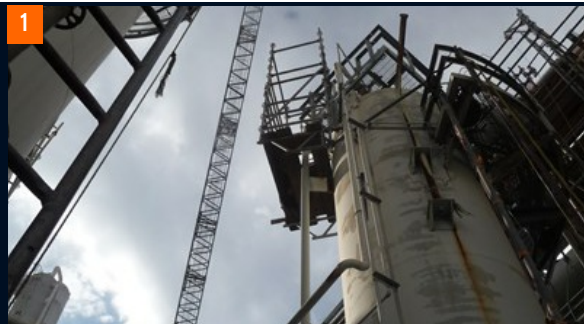
1. Vessel exterior
2. Vessel floor and wall
3. Close up of pitting
4. Finished project

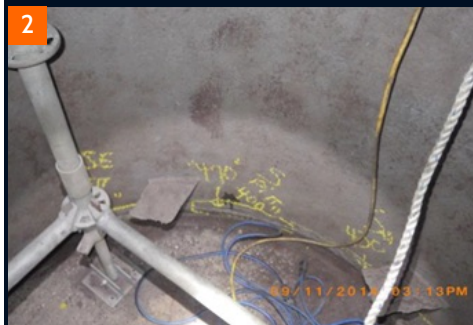
Corrosive process environment used in treating Heavy Gas and Natural Gas caused excessive pitting to vessel walls. Not only did coating have to stand up to this environment it needed to withstand steam out approaching 400F.

Application was carried out in accordance with a specific Method Statement developed for this project which included Belzona Know-How System Leaflet TCC-3 for repairing/renewing damaged linings. Belzona 1111 was used for pit filling; Belzona 5892 was applied using a brush as a two coat system in accordance with Belzona Instructions For Use.
