# BELZONA STOPS CLARIFIER LEAK EXTERNALLY

ID: 5422

Leak at clarifier wall

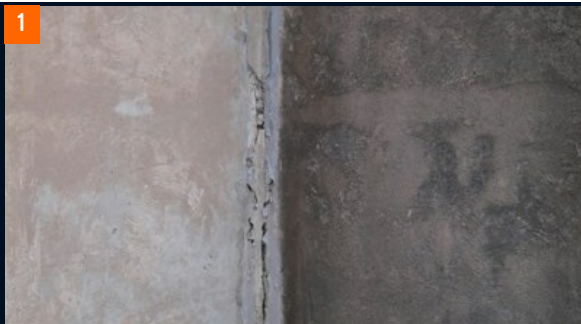
The leak was causing an environmental hazard as well as slippery walkways for pedestrians. The customer could not drain the unit. An external repair was needed to stop the leak.

1. The application area before repair
2. The application area before the area
3. The area after the application and leak free

Application was carried out using a modified version of Belzona Know-How System Leaflet VPF-11. Belzona 1291 was used to stop the initial leak, then Belzona 1161 was applied with Belzona 9341 reinforcement cloth over the entire area.
