# BELZONA REPAIRS STEEL PIPE ELBOW AT A POWER PLANT

ID: 5423

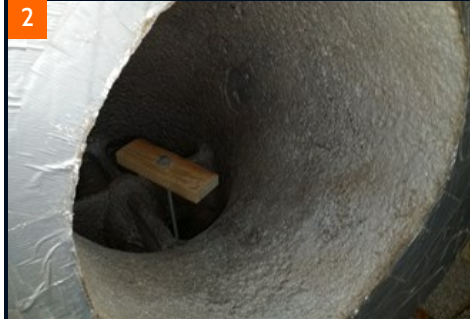
Very old pipe elbow needed to be replaced due to high corrosive pitting. It was close to having holes through to the concrete foundation of the historic building (power house).

1. Pipe elbow before the application
2. Pipe elbow after Sponge-Jet Blasting
3. Pipe elbow after application of Belzona 1311
4. Pipe elbow after application of Belzona 1321
