# BELZONA REPAIRS A RUBBER IMPELLER AT A SUGAR MILL

ID: 5424

Sugar mill pump impeller

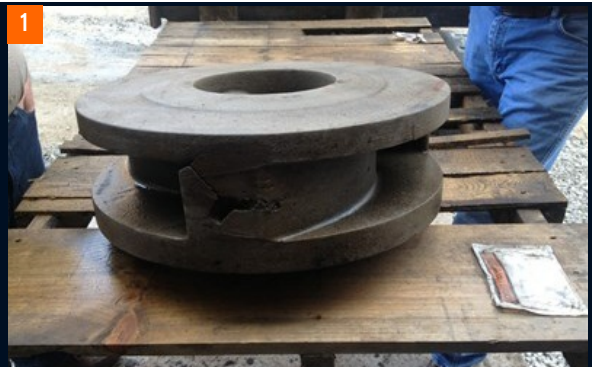
After years of use, impeller had cuts and holes that had to be repaired or impeller be replaced. The mill did not want to buy a new one if the impeller could be repaired.

1. Impeller before repairs
2. Worst area after degreasing; ready to be roughened up
3. Worst area after Belzona application
4. Finished repaired impeller ready for another grind season.
