# BELZONA REPAIRS A TANK ROOF AND SAVES THE PLANT FROM SHUTDOWN

ID: 5427

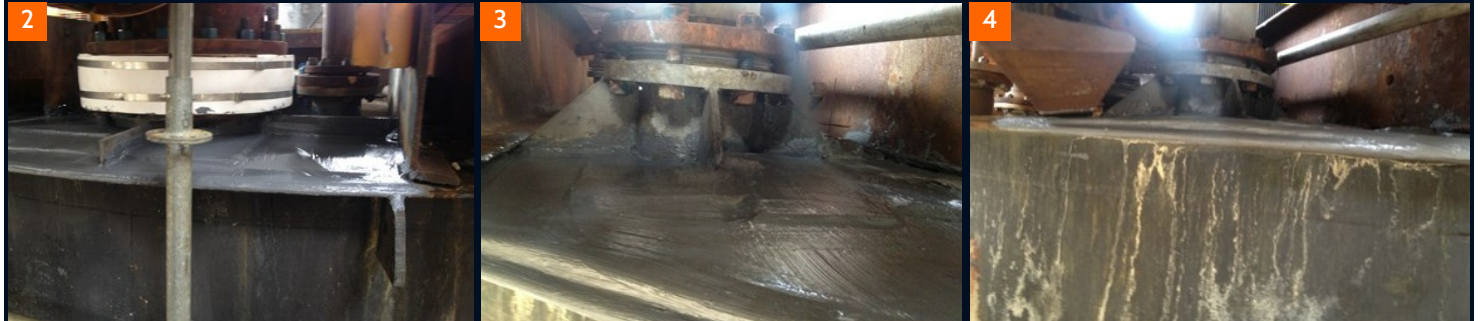
Vapors were escaping from the tank due to tank top separating. Vapors were also thinning metal in about a 60 sq. ft. area. Customer had welded plates over holes but needed a coating with resistance to sulfuric acid vapors.

Holes and corrosion on top of sulfuric acid tank and separated top of tank.

1. Separation of top from tank
2. After coating with Belzona 1161 and Belzona 4301
3. Sealing of holes and cracks
4. Tank top sealed with Belzona products

The application was carried out in accordance with Belzona Know-How System Leaflets TCC-1 & TCC-5.

Belzona 1161 (Super UW-Metal)  
Belzona 9341 (Reinforcement Tape)  
Belzona 4301 (Magma CR Hi-Build)
