# BELZONA REMEDIATES A DOCK AT A SUGAR REFINERY

ID: 5428

Concrete Dock at a Sugar Refinery

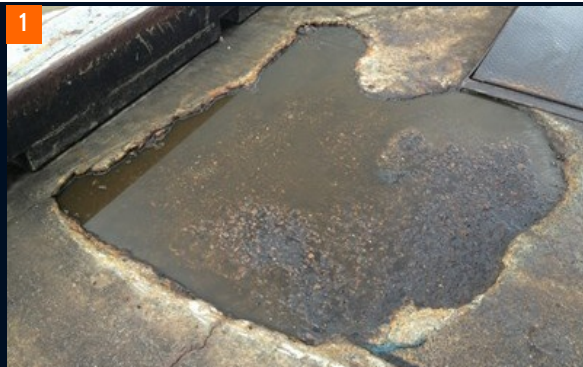
Abuse from the metal tractor wheels combined with sugar and water causing concrete to be eroded. The dock was becoming unsafe for equipment and pedestrians.

1. Before the application in the first area
2. Application complete in the first area
3. Before the application in the second area
4. Application complete in the second area

Application was carried out in accordance with Belzona Know-How System Leaflet FPA-1.

Belzona 4111 (Magma Quartz)  
Belzona 4911 (Magma TX Conditioner)  
Belzona 9111 (Cleaner/Degreaser)
