# SHOWER REPAIRED AND PROTECTED WITH BELZONA

ID: 5429

Shower stalls on a dredge boat. Boat has 49 showers.

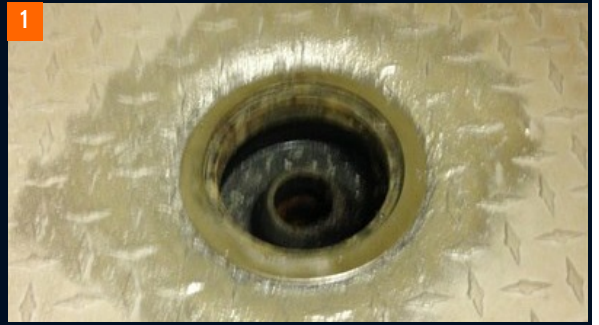
Crew was using cleaner on shower that was not supposed to be used on aluminum. Cleaner was eroding the metal. Shower floor made of aluminum and drains are brass. Bimetallic corrosion was occurring at drain. So, basically 2 different problems were occurring and destroying the shower floor.

1. Drain prepared for Belzona application
2. Belzona metal filled in areas where corrosion was occurring
3. Holes had appeared from using the chemical cleaner
4. Application completed

Application was carried out in accordance with a modified version of Belzona Know-How System Leaflet FPA-1.
