# BELZONA STOPS THE LEAK ON FIREWATER SYSTEM

ID: 5430

Firewater piping at a tank terminal.

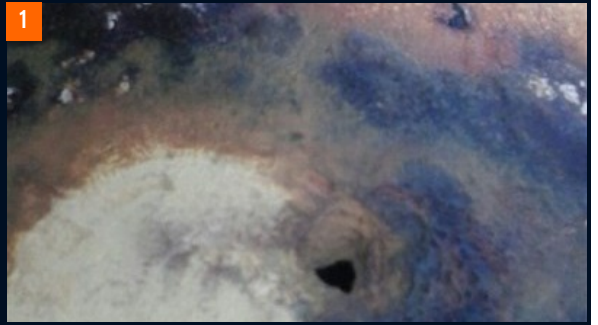
The piping was old and had not been taken care of. Many clamps on the lines, but leaks were starting to appear under the clamps. There were other places in the line where actual holes had appeared from corrosion.

1. One of the holes in the pipe
2. Water flowing from the pipe
3. Area of the pipe that was leaking
4. Application completed
