# BELZONA REPAIRS A DOCK HOSE BEFORE INSPECTION

ID: 5431

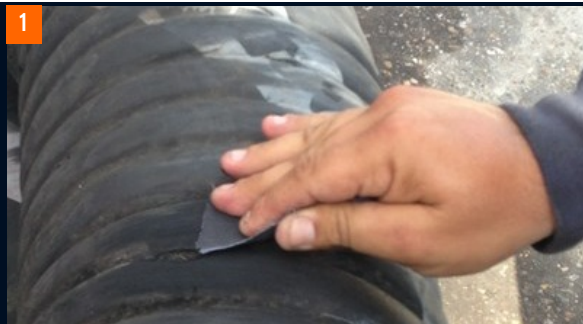
Over the years as the dock hose had been drug around the deck and over shipside, the hose had been cut and gouged.

1. Area being prepared for repair.
2. Area after Belzona 2911 applied.
3. Belzona 2311 applied.
4. Finished repair before tape removed.

After proper surface preparation, the application was carried out in accordance with a modified version of Belzona Know-How System Leaflet SOS-12.
