# BELZONA REPAIRS A CONVEYOR BELT

ID: 5432

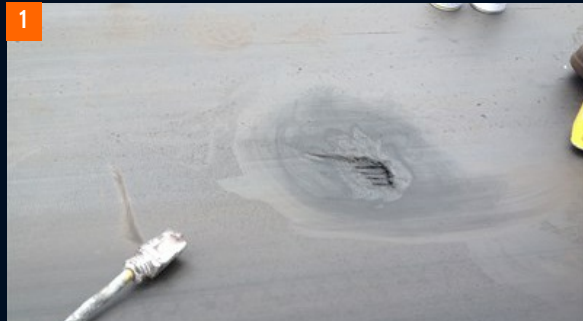
Conveyor belt had a 2" x 2" piece of rubber missing.

1. The area prepared for repair
2. Application is complete

The application was carried out in accordance with Belzona Know-How System Leaflet SHM-1. The hole in the belt was filled with Belzona 2311.
