# BELZONA PROVIDES A NEW SEAMLESS FLOOR AT A SCHOOL

ID: 5438

School bathroom and classroom floors.

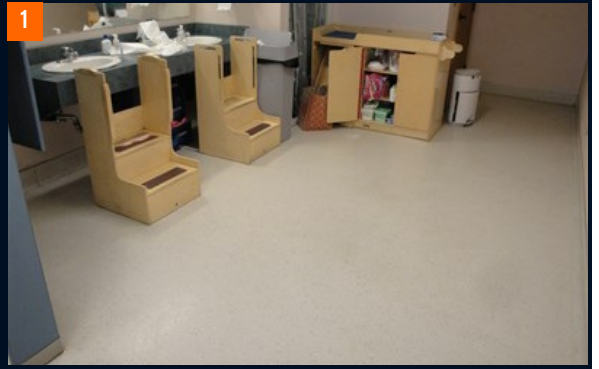
After twenty years the laminate flooring suffered from age and had become unsanitary. Odor and visible delamination of the laminate was a concern.

1. Laminate failing in several areas
2. Showing signs of use
3. Seams suspect to hygiene standards
4. Happy customer in a healthy & safe environment

Belzona provided the client with the solution to eliminate safety and health challenges. The adhesion near the seams was failing and delamination increased tears and created holes, so the removal of the contaminated linoleum flooring was of the essence. After adequate preparation of the concrete, Belzona 5231 was applied in two coats, freshening up and creating a safe and healthy area. The application of Belzona 5231 took place after 6pm and was ready for foot traffic by the next morning.
