# BELZONA REBUILDS AND PROTECTS FERRY RUDDER HORNS

ID: 5441

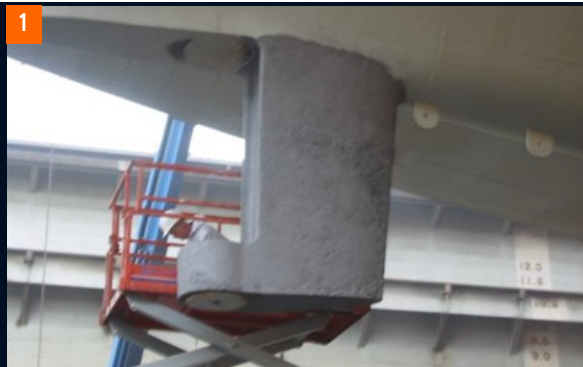
The rudder horns are subject to both erosion and cavitation damage.

1. Rudder horn after grit blasting to a near white metal finish 2. Application of 1st coat in progress 3. Completed application

Rebuilding eroded areas with Belzona rebuilding compounds is both quick and effective saving many hours of dry docking time. The conventional way would be welding.
