# BELZONA REBUILDS AND PROTECTS RUDDERS

ID: 5442

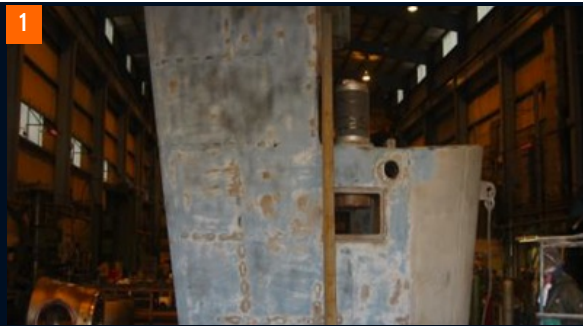
1. Rudders in set up after blasting ready for application. 2. Rudders after application of 2 coats of Belzona 1341 Supermetalglide. 3. Condition of rudders / rudder horn after 2½ years of service with Belzona coating.
