# BELZONA USED FOR EMERGENCY BOW THRUSTER REPAIR

ID: 5445

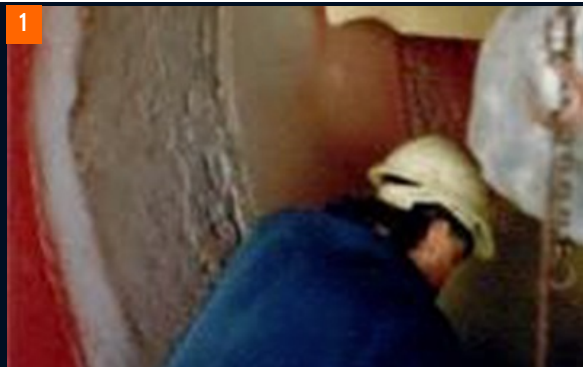
Bow thruster insert was suffering from major corrosion-erosion problems.

1. Preparation of bow thruster underway with a check on actual metal thickness.
2. Close up showing extent of problem.
3. Completed application.

The application was carried out in accordance with Belzona Know-How System Leaflet SOS-1.
