# BELZONA REBUILDS BOW THRUSTER

ID: 5446

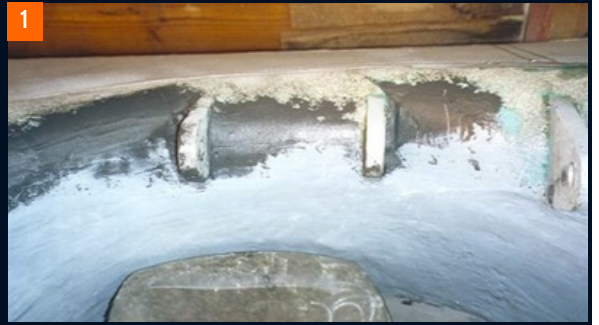
The fiberglass surround designed to eliminate bimetallic corrosion around the bow thruster insert was not able to protect the area from cavitation attack.

1. Fairing in the damaged areas. 2. Fairing in the damaged areas. 3. Entire bow thruster protected with 2 coats of Belzona 1341 Supermetalgilde.

The use of Belzona allowed localized repairs to be executed with a minimal amount of down time.
