# BELZONA 1341 SUPERMETALGLIDE PROTECTS RUDDERS

ID: 5449

Rudders were showing severe metal loss in areas where cavitation attack prevalent.

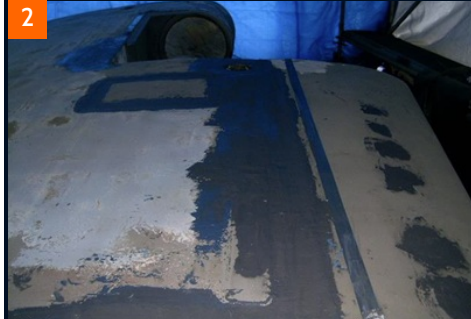
1. View of one of the many badly cavitated areas on the two rudders 2. Rebuilding of eroded areas in progress 3. Application of 1st coat of Belzona 1341 in progress 4. Application of 2nd coat of Belzona 1341 completed
