# BELZONA ROLLER REPAIR

ID: 545

The roller in a vertical mill at a large cement factory.

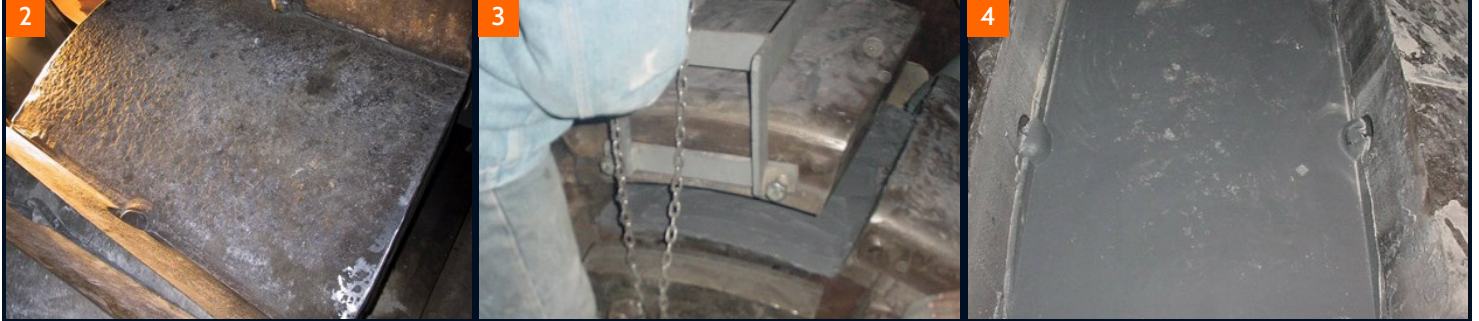
Excessive wear under the steel tile of the roller due to failure of steel tile during operation.

1. General view of the roller
2. The wear under the steel tile of the roller
3. Forming the worn out area using the steel tile
4. Application complete

Application was carried out in accordance with Belzona Know-How System Leaflet TCC-13.

Belzona was used to perfectly repair the roller in place, returning the worn out surface to its original dimensions with minimum down time and cost. Alternatives would be hard to apply due to the huge size of the roller and would have required significantly more money and time. This application is still in service and has become a standard repair procedure on similar equipment.
