# BELZONA REBUILDS RUDDER SHAFTS

ID: 5452

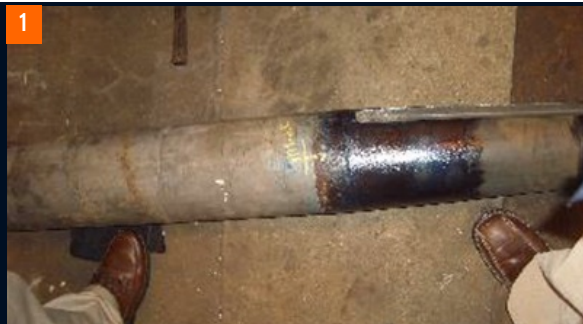
Tail shafts have suffered from extensive loss of metal.

1. Original shaft showing eroded area.
2. Rebuild of shafts completed.
3. Shafts machined and ready for installation.
