# BELZONA REPAIRS CONCRETE RAMP

ID: 5457

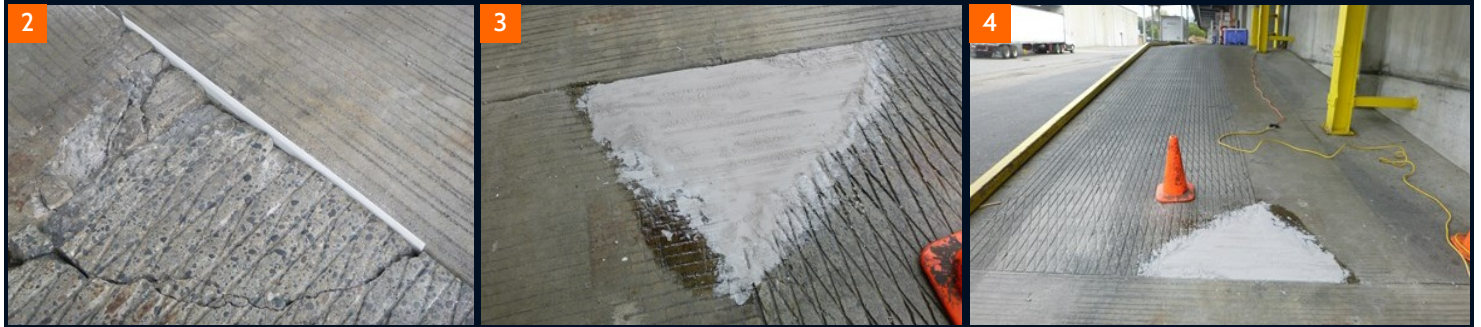
## PHOTOS

The foundation under the loading ramp had been undermined causing one concrete panel to crack which made a bump in the road for forklifts, which would then lose loads when hitting this joint.

1. Area on forklift ramp for repair
2. Teflon spacer fit into joint to separate adjacent panels
3. Conditioner (seen around edge) and 4111 applied to repair area
4. The ramp repaired from a distance

The application was carried in accordance with Belzona Know-How System Leaflet FPA-1. The substrate was thoroughly cleaned and loose material removed. A Teflon spacer was placed into the joint to separate adjacent panels thus avoiding a repeat of cracking that had occurred. The Conditioner was brush applied and Belzona 4111 was hand applied.
