# BELZONA REBUILDS ERODED RUDDER BUSHINGS

ID: 5459

Rudder bushings

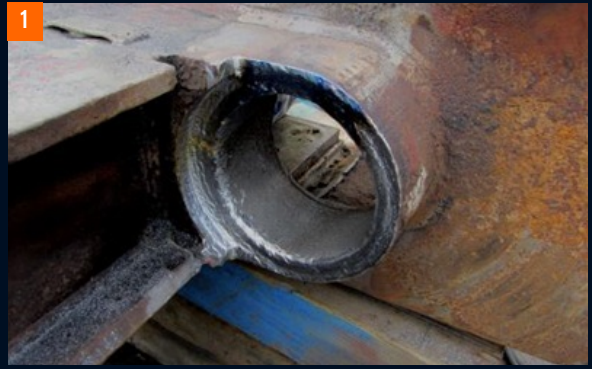
The bushing areas had suffered serious bi-metallic erosion.

1. The eroded bronze bushing removed.
2. Bushing fitted for a dry run.
3. Belzona 1111 applied and the whole assembly squeezed into place using a purpose made clamp.
4. Completed application.
