# BELZONA REPAIRS SHIPS GENERATOR SHAFT

ID: 546

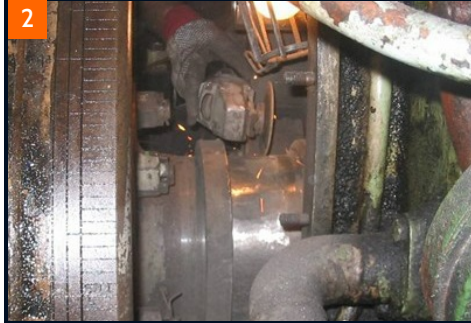
Worn generator drive shaft located in a narrow, confined place.

1. View of the generator shaft prior to the repair.
2. Surface preparation in progress.
3. Form was applied. Then excess material was removed.
4. Completed shaft repair.

Belzona successfully repaired the shaft in a cramped environment without disassembling the shaft. This allowed the ship to keep schedule without delay.
