# BELZONA STOPS TANK LEAK AT NUCLEAR POWER PLANT

ID: 5460

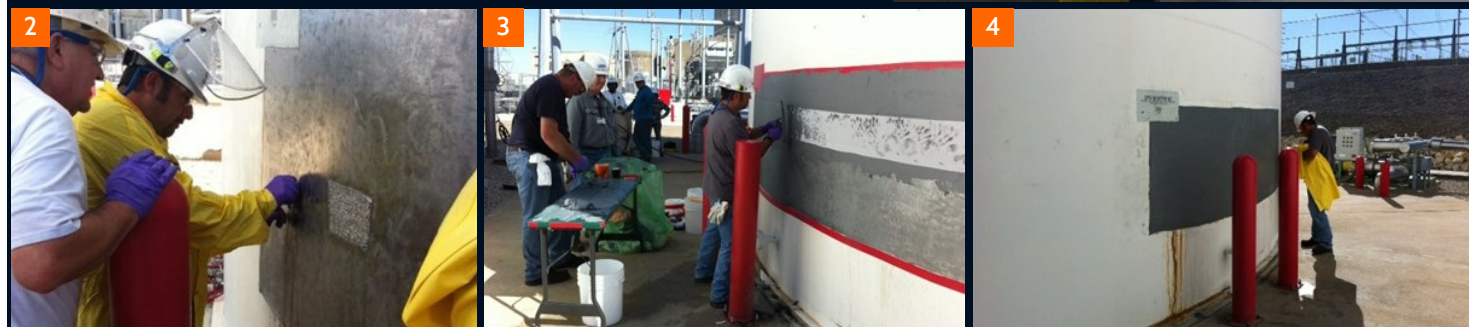
Pinholes developed in the tank that is used for emergency backup water for refueling. After testing it was discovered that a large area of the 3/16" steel sidewall was only .050 thick.

1. Plugging active leak
2. Patching over Belzona 1291
3. Applying Belzona 1111 with Belzona 9431
4. Completed application

The paint was removed and the surface was steel grit blasted to a 3 mil profile. Two of the pinholes were 1/2" in diameter and bolts with flat washers were coated with Belzona 1291 and placed into the holes. The third hole was 1/8" diameter and a sheet metal screw with a flat washer was coated with Belzona 1291 and placed into the hole. The first layer of Belzona 1111 was applied about 1/8" thick. Then Belzona 9431 was applied with the second coat of Belzona 1111.
