# ROOF PROTECTION TO RESERVOIR VALVE TOWER

ID: 5461

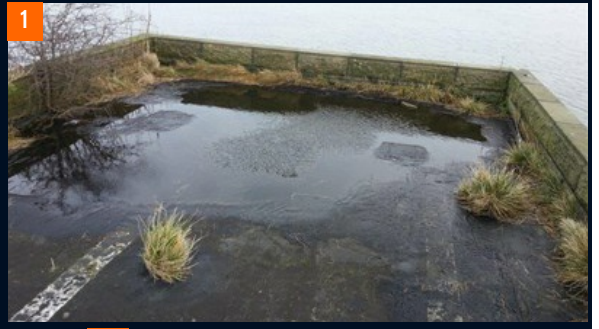
Damage to asphalt coated roof causing water ingress resulting in spalling concrete underneath. There was also severe plant growth.

1. Standing water causing damage 2. Damage to substrate 3. Completed Repair 4. Isolated Location

The application was carried out in accordance with FPA-1, RPA-1 and RPA-6. All of the damaged asphalt and plant growth was removed and the damaged concrete was rebuilt with Belzona 4131. Belzona 3131 was subsequently applied to the entire area to prevent further water ingress.
