# BELZONA REPAIRS LEAKING PIPE IN ABRASIVE ENVIRONMENT

ID: 5463

Cicra. 177mm O.D. Leaking Pipe

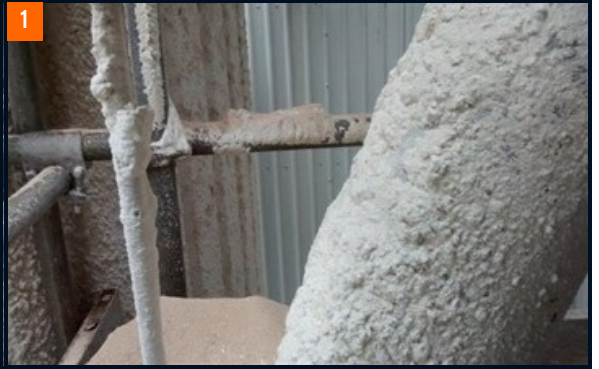
The dry bran within the pipe was causing abrasion leading to a 10mm hole on the outside of a large bend.

1. Holed pipe 2. Belzona 1812 being applied over Belzona 1321 3. Completed Belzona 1812 Application 4. Excess Belzona 1321 Application
