# BELZONA RENEWS HOG ELBOW

ID: 5464

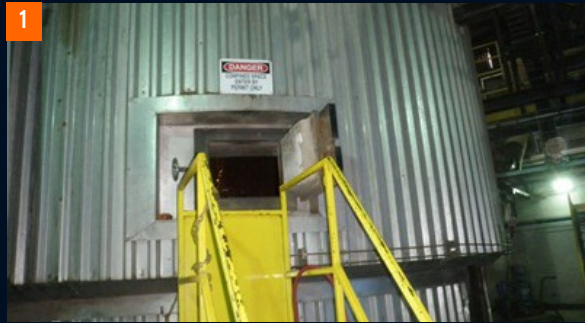
1. The burn chamber exterior and access door.
2. The interior of the elbow from above. The Belzona product from the original application 10 years ago is still visible.
3. Completed application.

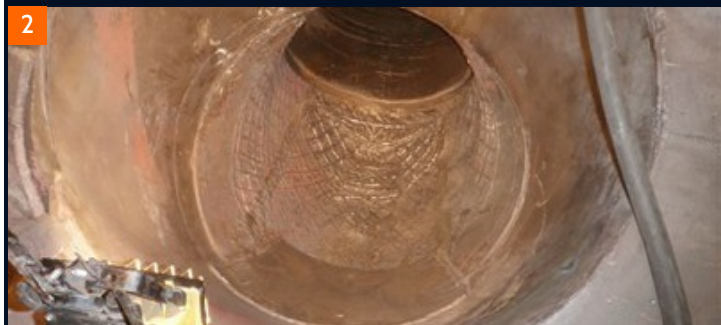
The elbow wears where at one point it was criss-crossed with an AR weld. Unfortunately, the fuel feed would hang up on the AR weld pattern, causing the auger to work much harder.

This elbow is one of three originally surfaced in 2004 with Belzona 1812, which was found to not only protect the elbow, but significantly reduce auger torque as well. 10 years later this elbow needed a new coating and Belzona was asked to renew the application.

The application was carried out in accordance with Belzona Know-How System Leaflet SHM-8. The surface was grit blasted; Belzona 1812 was applied by applicator and it was then overcoated with Belzona 1321 for smoothness.
