# BELZONA REBUILDS DAMAGED LOADING BAY

ID: 5467

Damaged loading bay

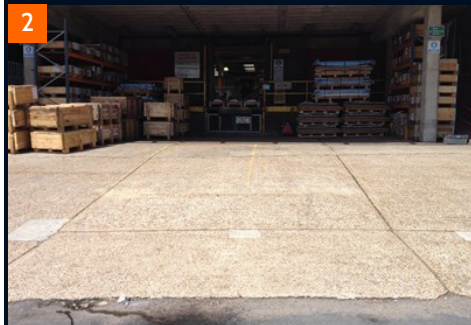
The loading Bay to this factory has a gradient levelling off down at road level. When lorries load and unload they have to reverse from the road up the gradient and into the loading area. At the start of the gradient lorries wheels lose traction causing abrasion and damage to the concrete. To overcome this, lorries take the run-up to the loading Bay, resulting in damage to the loading bay wall and potential injury to personnel. Over time the damage to the concrete slab has worsened making loading and unloading much more hazardous.

1. Damaged concrete 2. Incline of loading bay. 3. Completed Application 4. Completed Application

The application was carried out in accordance with Belzona Know How System .1. After surface preparation to remove any loose concrete, Belzona 4911 was applied to the entire area followed by a layer of Belzona 4131.
