# BELZONA FLOATING ROOF REPAIR

ID: 547

Crude oil leakage through welding seams in the tanks floating roof.

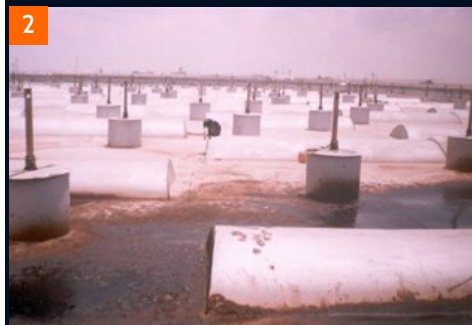
1. General view of the crude oil tank
2. The contaminated area of the floating roof
3. Cleaning the surface
4. Leakage stopped (shown) and in other locations

Belzona® 1291 was used to stop the active leak quickly. The flexibility and quick cure of Belzona® 2311 makes it the ideal choice for these types of applications. The Belzona will not crack from the movement of the roof up and down.
