# BELZONA RESTORES FLOTATION UNIT AT BIOMASS PLANT

ID: 5470

Dissolved Air Flotation (DAF) Unit in Biomass Plant

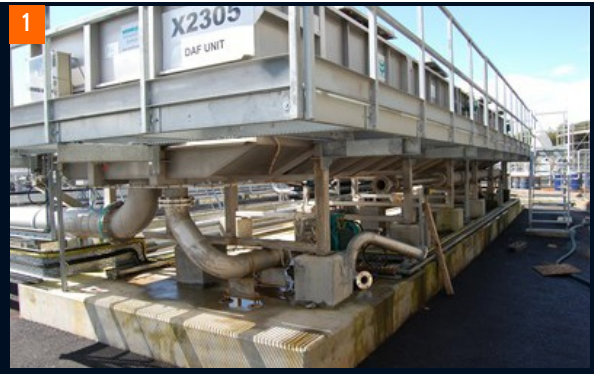
1. DAF unit
2. Pitting Corrosion
3. Plate bonding
4. Completed Application

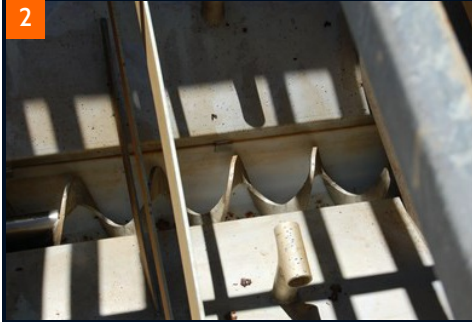
Severe pitting corrosion to the stainless steel unit caused by Ferric Chloride.

The application was carried out in accordance with TCC-1 and TCC-3. Belzona 1111 was used to rebuild the pitting damage. In deeply pitted areas doubler plates were bonded into place. Afterwards the full tank was lined with Belzona 5892.
