# BELZONA REBUILDS SPIRAL CASING OF A FRANCIS TURBINE

ID: 5471

Spiral casing of a Francis turbine.

Hydropower Plant, France

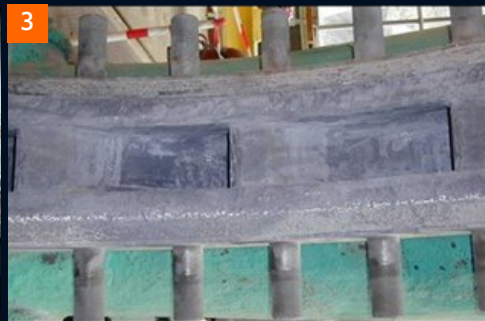
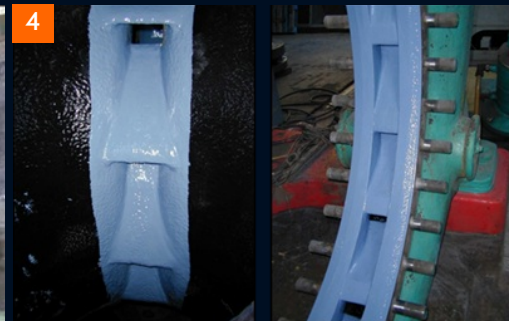
Corrosion, erosion and cavitation of the casing leading to vibrations and loss of efficiency.

1. Pump casing
2. After grit-blasting
3. Casing rebuilt with Belzona 1311
4. Completed repair with Belzona 1341 and Belzona 5811

The casing was rebuilt with Belzona 1311 in accordance with Belzona Know-How System Leaflet PDP-6 and then protected with Belzona 1341 where the turbine fits. Then, Belzona 5811 was applied on the other parts.
