# BELZONA REPAIRS AND PROTECTS BULB GENERATOR SET

ID: 5472

Bulb generator set.

Hydropower Plant - France

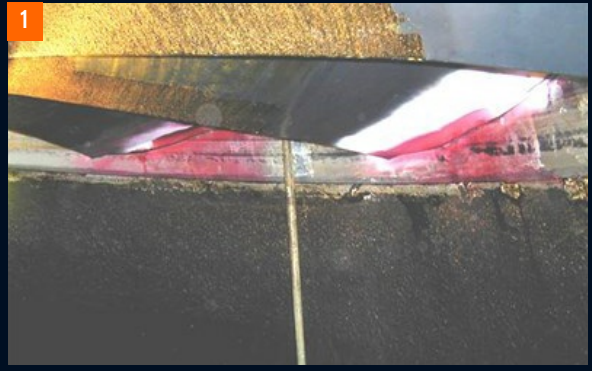
1. General view of the housing
2. Junction between steel and stainless steel
3. Completed repair and protection

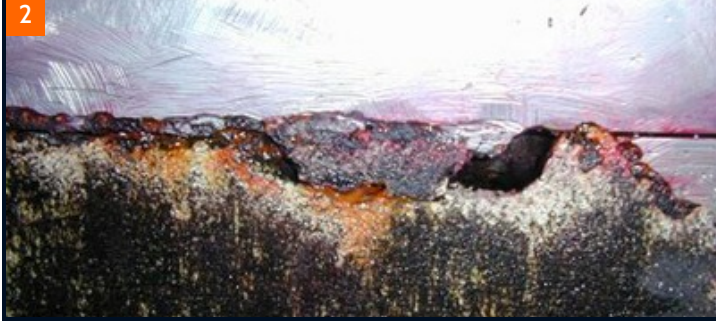
Important infiltration and corrosion between stainless steel jacket and turbine housing.

The damaged junction was repaired with Belzona 1111 and protected with Belzona 1341. The application was completed by the customer.
