# BELZONA PROTECTS CYCLONE

ID: 5473

Inside a cyclone transporting corncobs in a cereal plant.

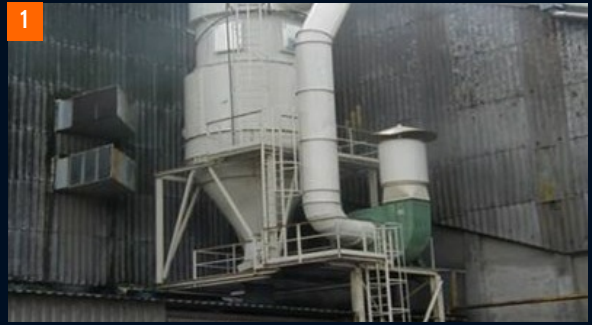
1. Cyclone to be repaired
2. Presence of holes due to abrasion
3. Repair with Belzona 1311 and protection with Belzona 1321

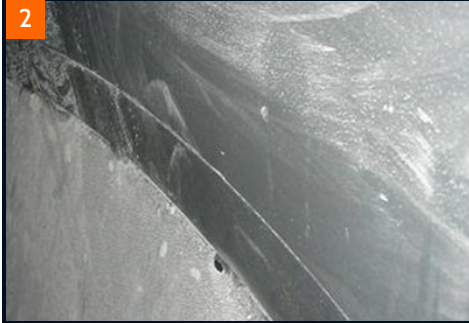
Abrasion inside the cyclone and through-wall damages caused by corncobs.
