# BELZONA PROTECTS BUFFER STONE WITH INTERNAL COATING

ID: 5474

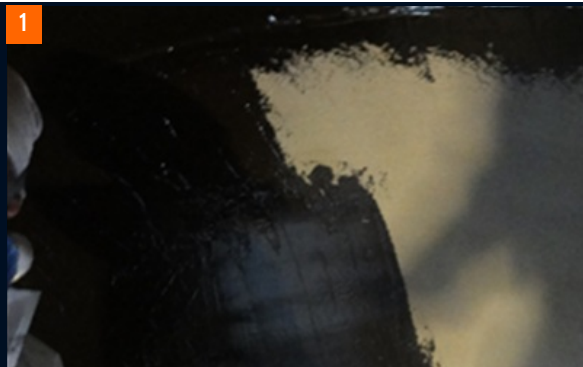
1. Application on grit-blasted substrate
2. Completing the application on the top part of the tank
3. Inspecting the thickness of the coating

The application was carried out during a shutdown of the refinery. The entire application was completed in a one coat system.
