# BELZONA PROTECTS THE DRINKING WATER

ID: 5476

40 year old irrigation/potable water pump.

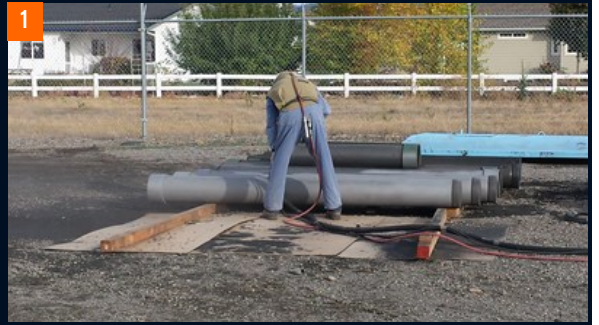
1. Gritblasting
2. First coat on the pipe
3. First coat on the pump
4. Second coat complete and ready for installation

The surface was grit blasted to Belzona standards of a near white finish. Then Belzona 5811DW was brush applied in two coats.
