# BELZONA MAKES FOR BETTER SHOPPING

Damaged concrete at a wholesale shopping store.

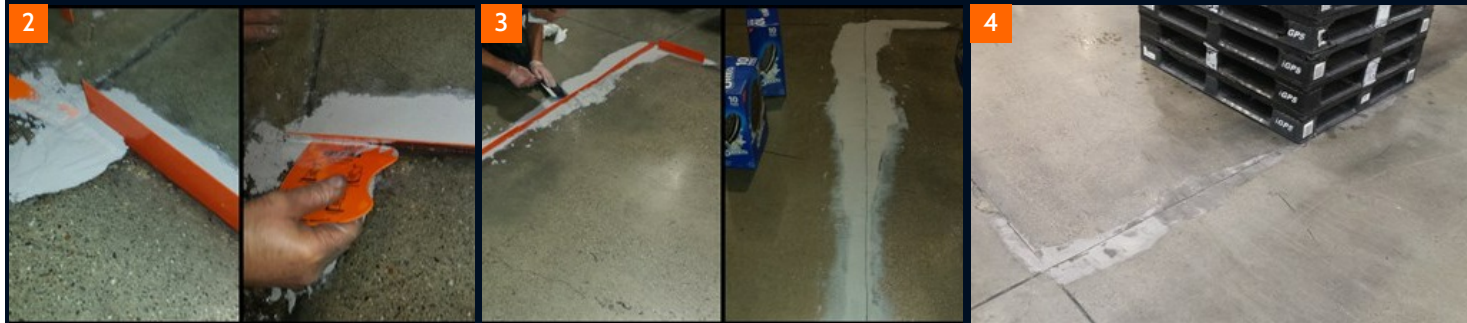
## PHOTOS

Concrete floor has broken out near a relief cut. With heavy forklift traffic during overnight stocking causing the damage, it is unsafe for pedestrian traffic during business hours. Previous patch material has been used but it breaks out soon after application, causing even more damage to the concrete.

1. Prior damage and patch. Patch removed.
2. Starting the application using the mixing board formers.
3. Finishing the application with the formers. After removing the formers.
4. One month later. Still looking brand new.

The application was carried out in accordance with a modified version of Belzona Know-How System Leaflet FPA-5 using 1" strips of a Belzona mixing board as the former to maintain the relief cut.
