# BELZONA REPAIRS 8" WATER PIPE/FLANGE

ID: 5478

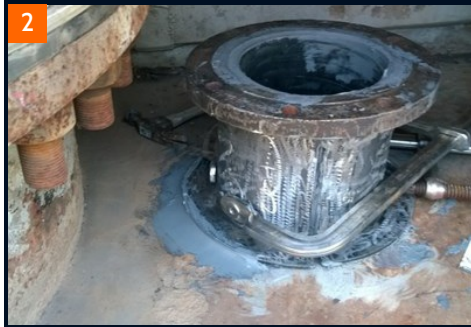
8" pipe had corroded all the way through the pipe in several areas around it. The heat condensers were installed directly above the flange and the pipe that returned cooled water back into the plant. There was not a lot of room to work with and the customer did not know how to seal or repair. They wanted a solution that would prevent the pipe from separating at the concrete level.

1. 8" pipe/flange in existing condition
2. Cold bonding process with Belzona 1121 to the interior and exterior sleeve
3. Two coats of Belzona 1321 on interior and exterior
4. Completed application and back in service

Corrosion was removed through grinding and the interior sleeve was then cold bonded with Belzona 1121. The voided areas and rough edges were then filled in with Belzona 1121 around the interior sleeve. The exterior sleeve to the 8" pipe and the concrete was cold bonded with Belzona 1121. Two coats of Belzona 1321 were applied on the interior and exterior.
