# BELZONA PROTECTS CONDENSER TUBE SHEET

Corrosion of the tube sheets of two condensers.

Steam unit condensers at a large power station.

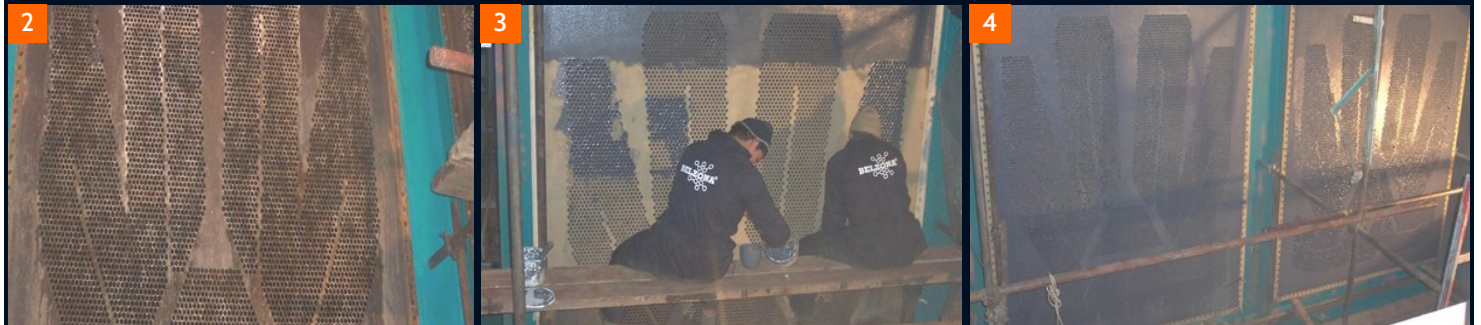
1. General view of the Condenser
2. The corroded tube sheet
3. Applying Belzona 1321 to the tube sheet
4. Completed application

Application was carried out in accordance with Belzona know-How system leaflet HEX-3.

Belzona 1321 (Ceramic S-Metal)
