# BELZONA HELPS FIREFIGHTERS DO THEIR JOB

Pump cavitation damage.

Water pump on a firetruck.

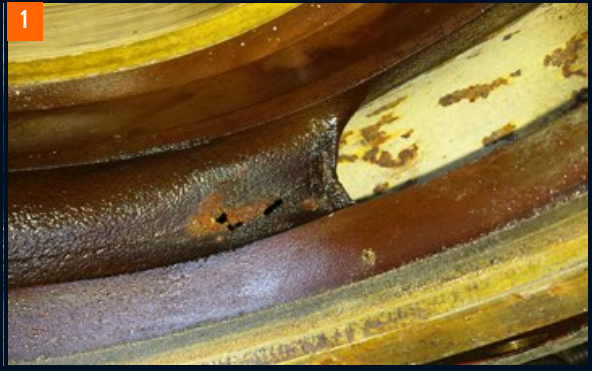
The existing pump was only 5 years old and showing heavy cavitation damage. The pump casing would have been fairly expensive to replace. With maybe \$5.00 USD of Belzona 1311 used to repair the damage and one unit of Belzona 1341 used to coat the impeller and the inside of the pump, it was a very cost effective repair. Additional benefits included an increase in the pump's efficiency when it was tested following reassembly.

1. Corrosion damage
2. Grit blasted and ready for the application of Belzona 1311
3. Application of Belzona 1311
4. All parts coated and ready for assembly

The application was carried out in accordance with the Belzona Know-How System Leaflets CEP-1 and CEP-3. Surface preparation was carried out by grit blasting to a near white finish. Belzona 1311 was applied by using a formed piece of applicator trimmed down to the same size and shape of the damaged volute area. Belzona 1341 was brush applied in two coats as recommended.
