# BELZONA BRINGS SHAFT BACK TO LIFE

ID: 5484

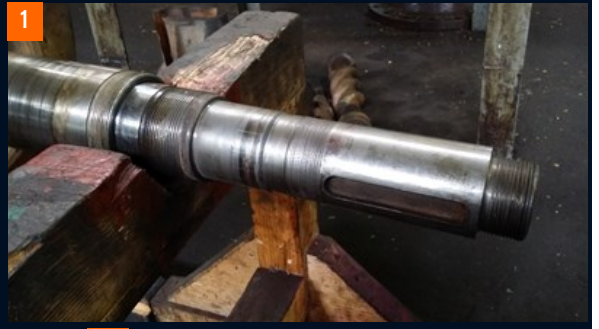
Failed bearings damaged the shaft and prevented it from operating correctly.

Worn shaft.

The application was carried out in accordance with a modified version of Belzona Know-How System Leaflet MPT-1. The shaft was roughly undercut 2 mm in depth, degreased with Belzona 9111, and rebuilt with Belzona 1121. Once it had cured solid, it was machined down to the correct dimensions.

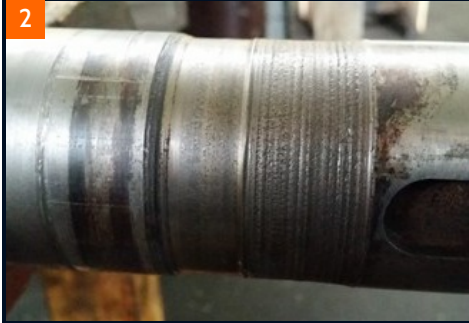
Loss of shaft's bearing surface caused failure of the bearings.

Closeup of worn shaft.

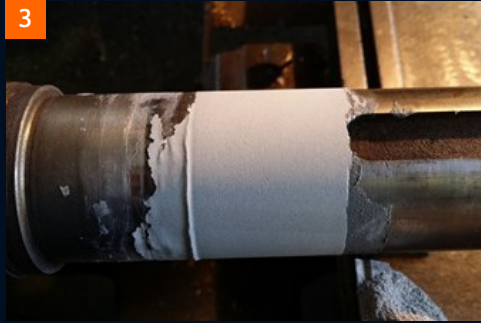
Rebuilt damaged area.

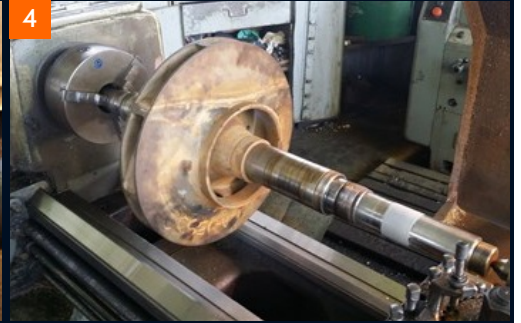
Complete shaft repair.
