# PROPELLER BLADES CAVITATION PROTECTION

ID: 5485

New propeller blades cavitation protection

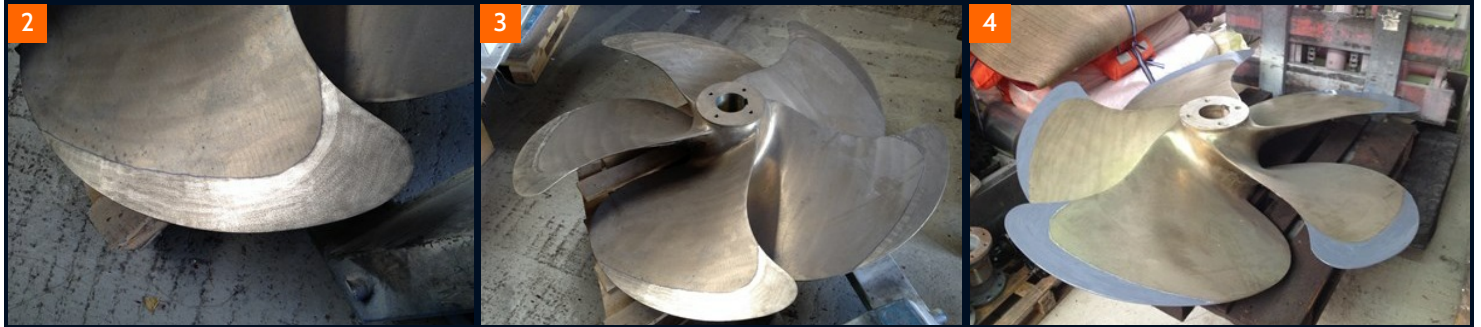
1. Propeller
2. Blade
3. Surface preparation
4. Belzona 1321 applied

The application was carried out in accordance with Belzona Know-How System Leaflet SOS-2. Blades were prepared to recommended profile roughness, degreased and coated with two layers of Belzona 1321.
