# BELZONA REPAIRS & PROTECTS FILTERS

ID: 549

Media filters for the hotels swimming pool.

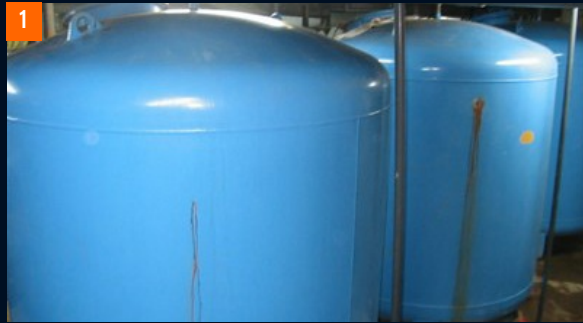
1. General view of the media filters
2. Holes caused by corrosion
3. Old coating failed
4. Coating was completed after all holes were plugged

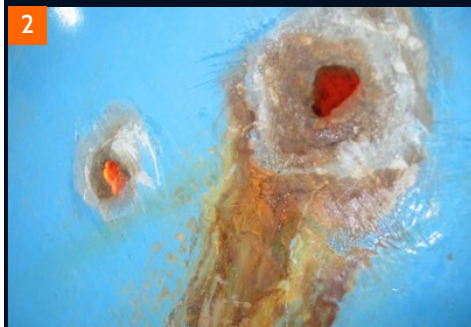
Severe corrosion of the filters after the failure of its internal coating. The corrosion also caused many holes in the bodies of the filters which were leaking during operation.

Previous coating had failed causing many holes and leaks. Belzona Marine Metal sealed all the holes, while Belzona® 1341 was used as a protective coating to prevent future corrosion. Belzona® 1341 also was chosen due to the fact that it is NSF Approved.
