# BELZONA PROVIDES NON-SLIP SURFACE AT SCHOOL ENTRANCE.

ID: 5499

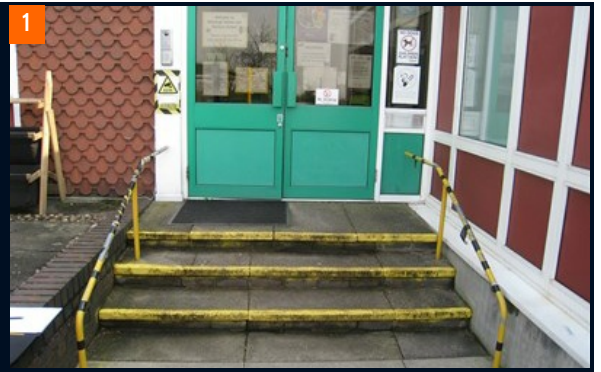
Steps presented a slip hazard to pupils, staff and visitors when entering and exiting the school.

Worn Steps

1. Damaged Steps 2. Damaged steps-close up 3. Completed Application 4. Completed Application - close up

The application was carried out in accordance with Belzona System Leaflet FPA-8. Belzona 9221 was encapsulated in the Belzona 4411 and applied in an even coat.

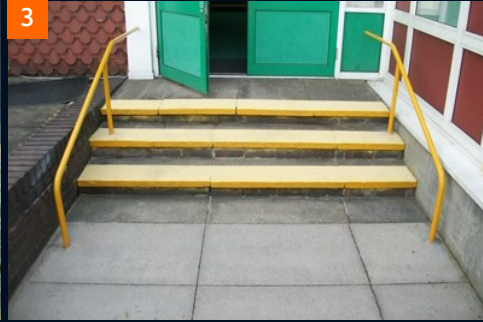
The school had used Belzona 4411 in the past and were pleased with the results and therefore chose Belzona again for this application. The entire application was completed in one day. The Belzona 4411 yellow provides a visual guide to the step nosings as well as a hard wearing non-slip surface.
