# BELZONA SAVES SIGNIFICANT DOWNTIME FOR CEMENT PLANT

ID: 550

Crusher shaft

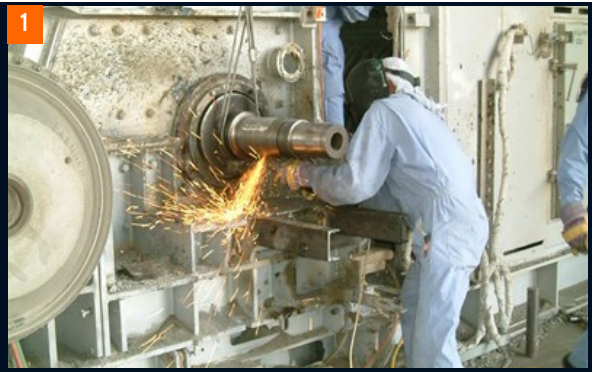
Bearing area of the 155mm shaft was down due to bearing failure, causing the entire operation to shut down.

1. Surface preparation in progress
2. Prepared surface, ready for Belzona to be applied
3. Completed application
4. General view of crusher shaft in operation after the application

Application was carried out in accordance with Belzona Know-How System Leaflet MPT-1 and MPT-2.
