# BELZONA RESTORES DAMAGED FLOOR IN PAPER PLANT

ID: 5508

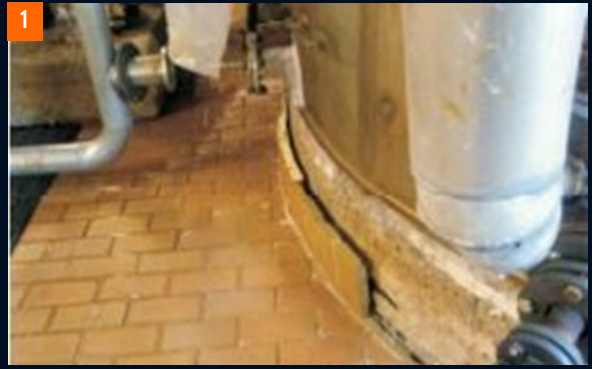
Chemicals had penetrated through the tiled surface leading to rapid degradation of the underlying concrete.

Tile floor damaged by chemicals including acids and alkalis.

1. Damaged tile flooring
2. Removal of the old damaged substrate
3. Restoration of the concrete floor base
4. Protecting the floor from the chemicals
