# BELZONA REPAIRS VACUUM PUMP

ID: 5509

Liquid ring vacuum pump.

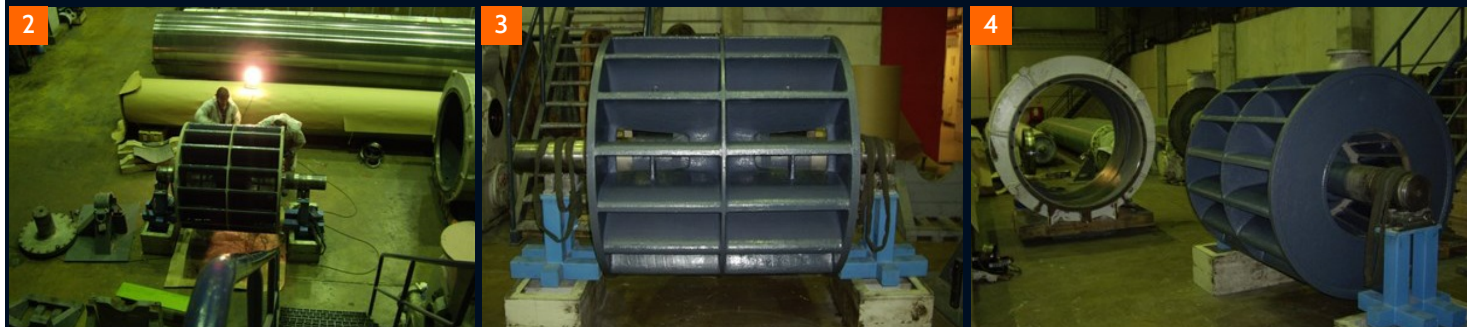
Pump casing, impeller and end plates damaged by erosion and corrosion as a result of handling medium contaminating the water seal, leading to a rapid loss in efficiency.

1. Surface preparation of pump impeller
2. Repair of the damaged pump rotor in progress
3. Close up view of restored side of the pump
4. Completed repair of the pump rotor and casing

The application was carried out in accordance with Belzona Know-How System Leaflets PDP-5 and PDP-6. The profiles were restored with Belzona 1311 before coating with Belzona 1321 to provide overall erosion-corrosion protection.
