# BELZONA REFURBISHES DRUM SCREEN

ID: 551

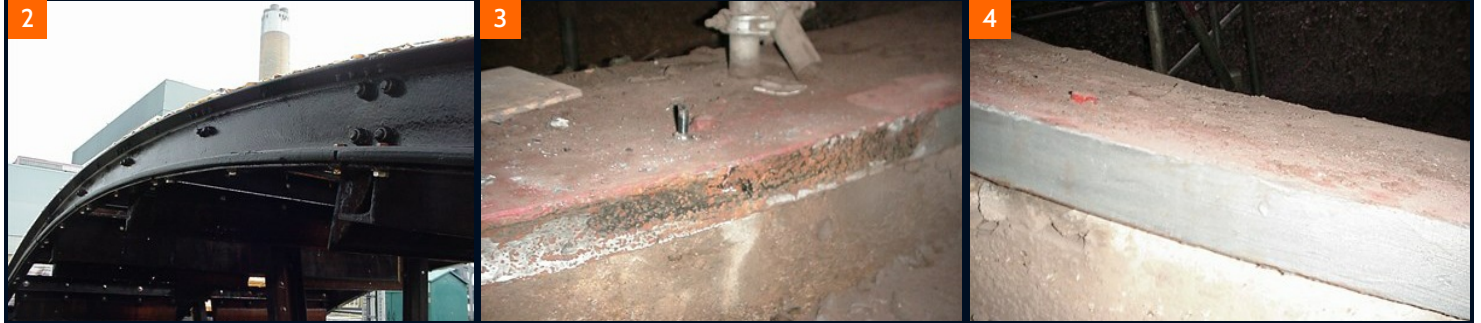
The rubber edge seal on the rotating screen wheel had, over many years, worn the steel mating edge in the chamber

1. General view of the drum screen
2. View of the rubber side seal
3. The eroded seal face
4. Seal face rebuilt with Belzona 1311

Application was carried out in accordance with a modified version of Belzona Know-How System Leaflet VPF-1. After thorough cleaning the profile was rebuilt with the Belzona® 1311.

Welding was being considered but this would have taken several weeks to complete as it would have involved removing the edge plates, welding and re-machining. The Belzona application was completed in-situ and in a fraction the time the welding option would have taken. Twenty-eight kilograms of Belzona® 1311 were used in the application.
