# BELZONA REPAIRS DRIER DRUM AT SUGAR FACTORY

ID: 5512

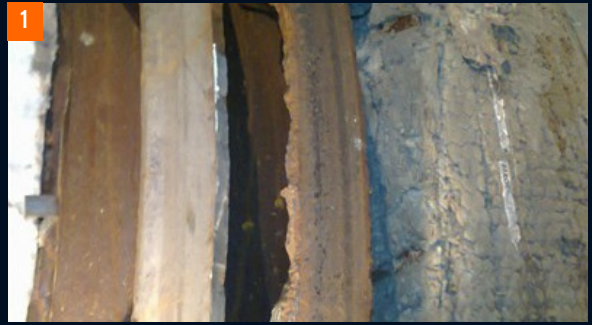
Corrosion and cracking had caused deterioration to the outer rim surface of the drier.

Damaged outer rim of the drier drum

1. Deteriorated metal rim of the drier drum
2. A metal plate fixed onto the side part of the rim using bolts and Belzona
3. Completed repair showing bonded metal plate and Belzona 1111
