# BELZONA SOLUTION FOR FEED WATER PIPELINE

ID: 5514

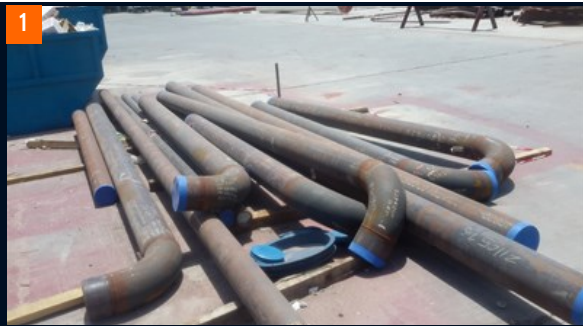
1. Pipeline sections
2. Spin spray rig
3. Pipeline sections being lined
4. Pipeline close up
