# BELZONA FORMS 2" 150PSI RATED FLANGES

ID: 5515

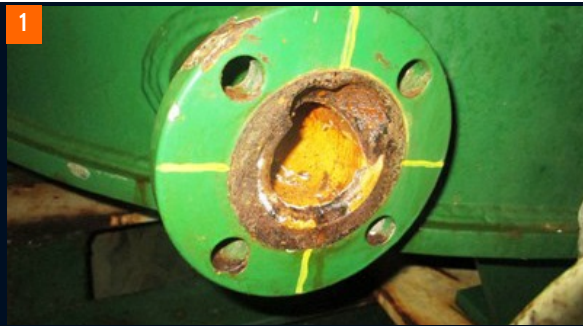
Existing coating had failed leading to corrosion of the vessel internals and severe loss of metal on the adjacent flanges.

1. Damaged flange face 2. Flange face after grit blasting 3. Belzona flange former in place 4. Completed application after removing former

Application was carried out in accordance with Belzona Know-How System Leaflet VPF-17 using the Belzona flange face forming kit.
