# BELZONA FLANGE FACE FORMING ON 4" 150PSI FLANGES

ID: 5516

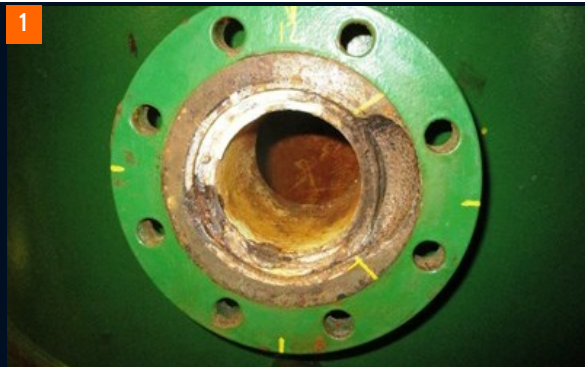
Existing coating had failed leading to corrosion of the vessel internals and severe loss of metal on the adjacent flanges.

1. Damaged flange face 2. Flange face after grit blasting and deep pitting roughly infilled with Belzona 1111 3. Belzona flange former in place 4. Completed application after removing former

Application was carried out in accordance with Belzona Know-How System Leaflet VPF-17 using the Belzona flange face forming kit.
